CHEMICAL PROCESSING

Texas Chemical Plant Validates Corrosion-Protection Performance of RMB Products' Rotationally Lined Fittings

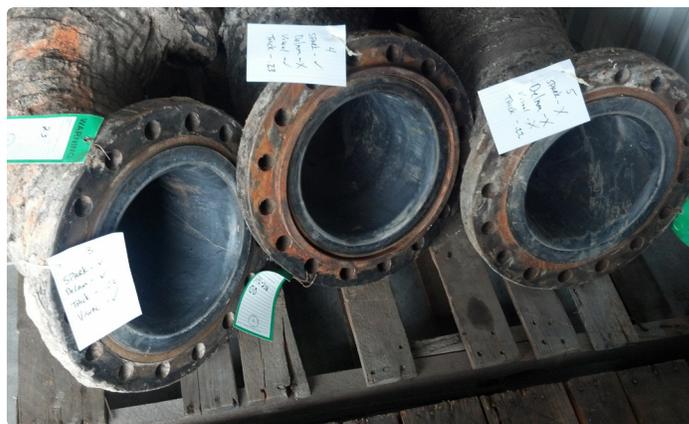
HDPE lined fittings after 15 years of service

Visual inspection. All liners were examined for cracks, gouges, nicks and abrasion. All fittings appeared to be in good shape: no missing fragments, exposed metal or scratches.

Spark test. All liners were subjected to a high-voltage electrostatic test per the NACE SP0274 standard. Fourteen of the 21 fittings (67%) passed the spark test after 15 years of use.

Lining thickness. The nominal lining thickness for the fittings was 0.320". At time of delivery, the minimum allowable thickness was 66% of nominal (or 0.2112") per the RMB Products lining specification. During the inspection, the minimum thickness found was 0.221". Despite 15 years of use, the lining thickness of every fitting was within the minimum allowed at the time the lining was completed. Furthermore, 16 of the 21 fittings had minimum lining thickness readings above 0.250".

At completion of the round of testing and inspection, RMB Products estimated that the fittings exhibited 3 to 5 years of additional service life before needing to be replaced. Because the cost of shutting down service again in 3 to 5 years greatly outweighed the cost of relining the fittings, the customer chose to have RMB Products remove the XLPE liners and replace them with new HDPE liners, confident that the components could be placed back underground for another 15 years with no service issues. RMB Products completed the relining project within 4 weeks, well within the time allocated for the scheduled shutdown.
